Manhole Inspection Summary

Manhole # S51M__028MH

Location Address: **2844 s. linwood**

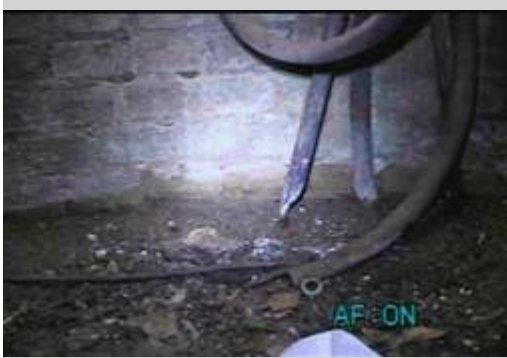
misc

Steps Count: **5** Missing: **2** ☒ **Corroded**

steps

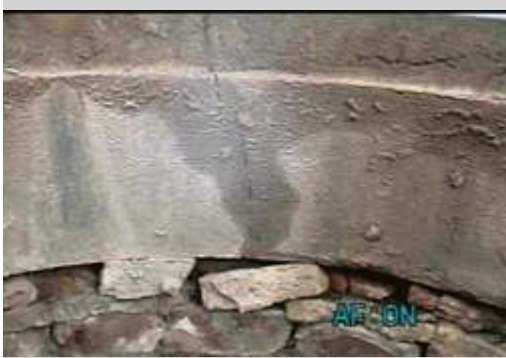
Defect 3

bench debris

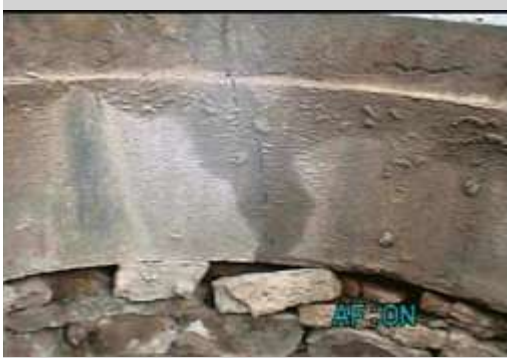
Defect 2

Condition: ☐ Sound ☐ Cracked ☐ Root Intrusion ☒ **Loose Brick** ☐ Deteriorated

chimney loose bricks, frame adjustment

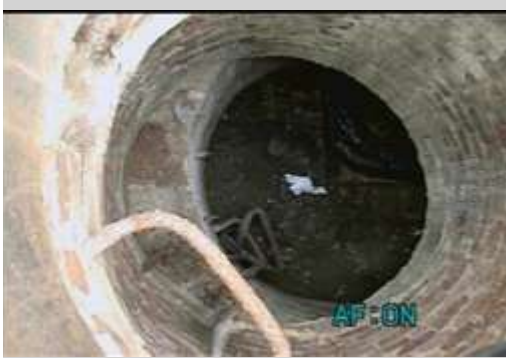
Defect 1

Frame Offset: **0** (in.) Condition: ☐ Sound ☒ **Cracked** ☐ Leaks

Cracks in frame
